Valencian *tapia* in the walled city of Mascarell (Castellón, Spain)

F. Taberner Pastor

Universitat Politècnica de València (Spain)

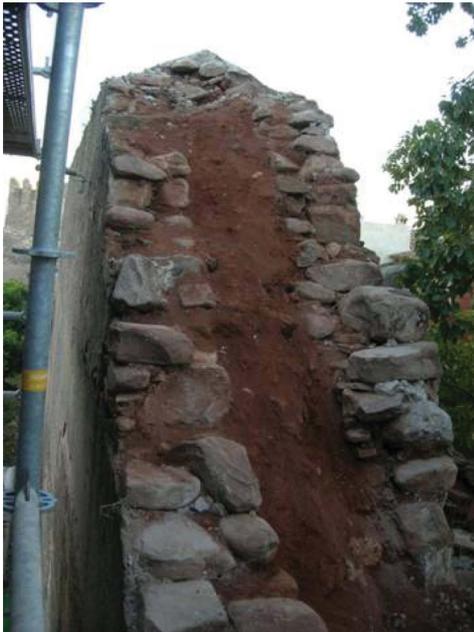
Figure 1. Section of the wall at the rebuilt in 1942 by the Dirección General de Regiones Devastadas.

However, the restoration of the wall did not adopt the valencian tapia system, but the layer of "valencian steely wall" -with its original bricks- was substituted by masonry. So the resulting wall was composed of a double leaf masonry made of lime mortar and cement mortar coating their outer faces, which hosted inside a mass of soil. As seen in the areas that suffered landslides, such mass was not properly compacted.

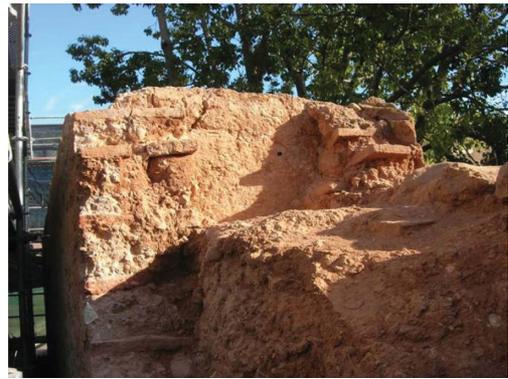
Figure 3. Detail of the original section in the union of two rammed earth walls.

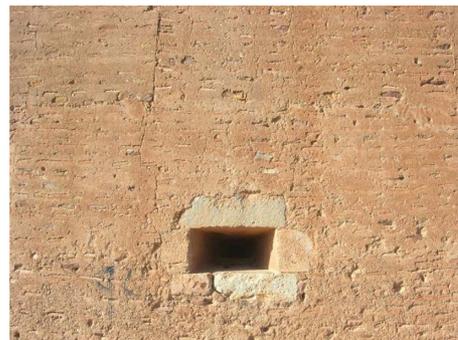
Figure 4. Aspect of the original finish on the tower of the Portal de l'Horta, with the pocket described in the contract.

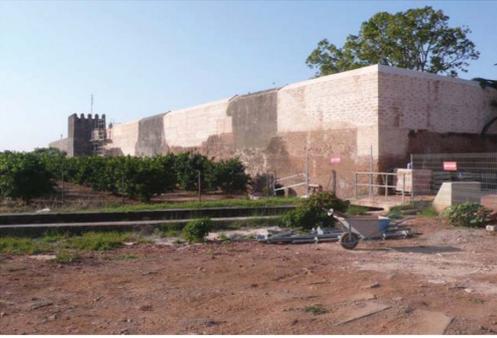
Figure 5. Appearance of finished wall.

In the restoration, we chose to use the traditional method, trying to build the five original rammed earth modules, of 3.70 m × 1.15 m, up again. The initial idea of demolishing part of the ramparts to redo some walls was completely discarded. The rammed earth wall shuttering was assembled, allowing the dumping and compacting of materials to be done. Thus, the new and the old work were united by stainless steel rods. The soil was moistened into a mixer, receiving a small supply of lime, and it was compacted by a manual rammer. The lime mortar, mixed with the soil of the place, together with a small portion of white cement to accelerate its setting, adopted a slightly pink tone. This is the color it has kept up to now. It contrasts, perhaps in excess, with the rest of the wall that would require a proper cleaning, what unfortunately was beyond the means of the job entrusted.

The top of the wall was performed as described in the original Contract: “cal y canto” (lime and mortar), and “esquena de gat” (cat-back shaped).

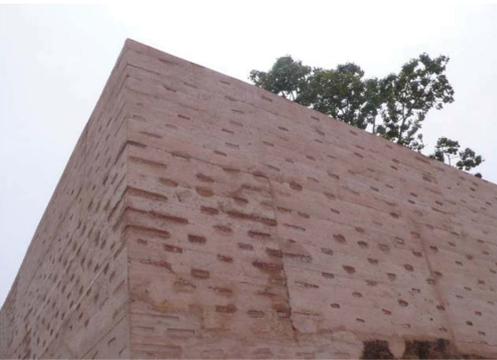
Figure 6. Detail of the wall.

It was also decided -given the lack of traces left by the rods- to hide the holes left after extraction. For that, 20 × 40 mm metal parts surrounded by plastic material were used, so as they could be easily removed by slightly tapping. The small holes left after rods removal were filled with the same mortar.
