About the rediscovery of the *tapia valenciana*

F. Iborra Bernad

ABSTRACT: The so-called *tapia valenciana* is a particular type of brick-reinforced rammed earth wall used in the area of Valencia between the 14th and 17th centuries. Replaced by brick or rubblework walls in the 18th and 19th centuries, the technique was forgotten until the 1980s. The text addresses pioneer contributions in this field with professionals like Manuel Galarza, Fermín Font and Pere Hidalgo, as well as some early approaches to the restoration of rammed earth.

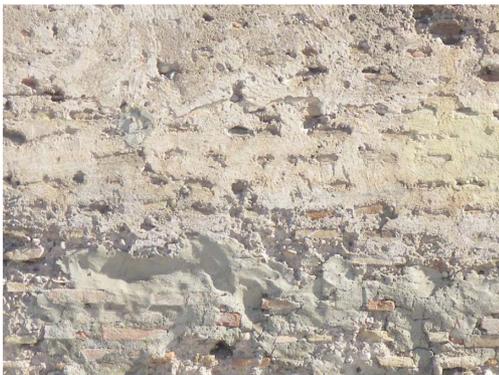
Figure 1. Unrestored *tapia valenciana* wall (San Miguel de los Reyes, Valencia).

The technique known as *tapia valenciana* is a variant of rammed earth wall reinforced with courses of bricks, visible from the outside. It was particularly successful in the Valencia area, and it is likely that the invention arose in these lands during the Middle Ages. Its origins can be traced back to the mid 14th century and it continued to be the main building system until the early 17th century, when brick or rubble gradually began to replace it (Cristini & Ruiz Checa 2009). After that, it fell into disuse in urban areas, and we can assume it was virtually extinct at the time of the construction boom in the 18th century.

strong structure” and constructions of this type that have survived to the present day are evidence of this. However, its main problem is deterioration caused by water infiltration, as in conventional lime-washed rammed earth walls.

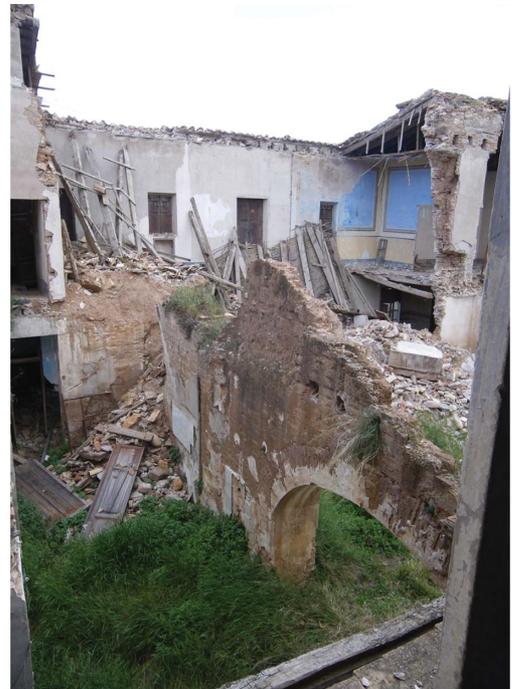
Figure 2. Collapsed *tapia valenciana* walls in a 16th century building (“El Relpá” in Alquerías del Niño Perdido, Castellón).

We must recognise the weakness of the walls of buildings without a roof or simply in areas seriously exposed to moisture. Furthermore, the reduced bearing capacity, measured by Proctor compaction tests in a new wall, is virtually impossible to assess in an old wall affected by water leaks. Uncertainty makes it easy to understand the fear or lack of security of the architects responsible for its restoration. In that sense, we appreciate even more a series of contributions that have helped to see this type of construction in a different light.

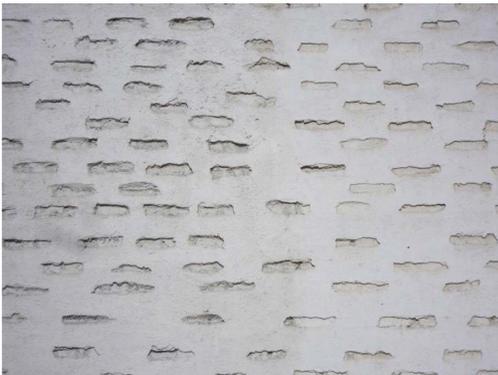
Figure 3. *Tapia valenciana* wall restored with a protective coating (*Almudín*, Valencia). Here two walls from different periods can be perceived.

In the case of the rammed earth wall, furthermore, a protective coating was selected.

“On the finished surface, depending on the texture as a result of the building procedure, it was decided to apply a protective coating to ensure the textural quality obtained, waterproofing compatibility with optimal levels of water vapour diffusion, protection against the aggressive effects of the atmosphere and carbonation and, finally, durability and adequate maintenance” (Llopis 1996).

Galarza’s criticisms are now more understandable. The recovery of the external image and the closure of some openings had led to the restoration of the texture of the wall with repairing mortar, even faking its characteristic finish. It is common practice even in the restoration of stone, especially in severely damaged areas. But it is true that it somehow a betrayal of the traditional technique. The second point concerns the homogenisation of the facing and sealing of joints between different construction phases, which now prevents a clear stratigraphic reading. Also in this sense we can understand it as a decision aimed at obtaining a unitary, unfragmented aspect, more architectural than archaeological.

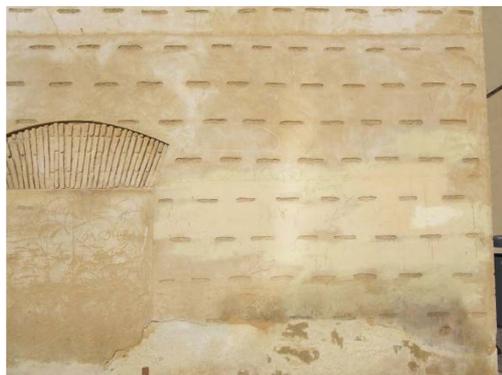
Figure 4. Fake *tapia valenciana* wall: an old wall coated with a textured rendering (*Gremio de Carpinteros*, Valencia).

From a certain distance, a *tapia valenciana* wall in a brown tone, similar to that of *Almudín*, is visible. In any case, the excessive separation between the rows of brick and the shade are unusual. However, when we come, we realise that the effect is caused by a rendering on which a false finish of bricks has been applied. The building dates from the 16th century and its walls are really made of *tapia valenciana*, as we can see in some areas. However, it is clear that in this case it was decided to keep the original material, probably in very poor condition, hidden and to simulate it on the surface as described above.

We suppose that the intention of the designer was to evoke the original wall without deceit, with a modern technique fully recognisable, according to the tenets of critical restoration. The result, in any case, is unique and is definitely a factor that contributes to the success of the works on the *Almudín*.

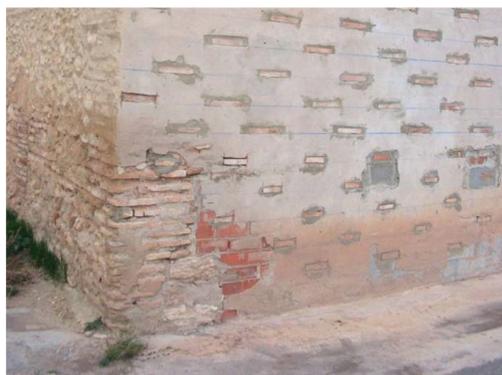
Figure 5. Fake *tapia valenciana* wall: new wall coated with a rendering into which the bricks are inserted (Alquería de Pinohermoso, Burjassot, near Valencia).

In an intermediate line, we might consider the ingenious recuperation of the image of *tapia valenciana* in the Alquería de Pinohermoso, in the town of Burjassot. The building, one of the medieval farmhouses in the Valencian countryside, had suffered a progressive decline throughout the 20th century, and had ended up in a state of ruin. Besides the loss of floor and roof, in recent decades the walls of the main façade had collapsed. Recently acquired by a new owner, its rehabilitation was undertaken to be used as a second residence. In this case, the walls were rebuilt with new material and then “transformed” into *tapia valenciana* with a layer of mortar and bricks -or fragments of brick- embedded afterwards. It would have been preferable to build the wall in the traditional way, but even so, the recovery of the farm, a landmark that was destined to disappear, must be celebrated.
