## The valencian rammed-earth wall (“*tapia valenciana*”) in the restoration of Alaquàs Castle (Valencia, Spain)

S. Tormo Esteve, V. García Martínez, L. Cortés Meseguer & L. Palaia Pérez

*Universitat Politècnica de València, Spain*

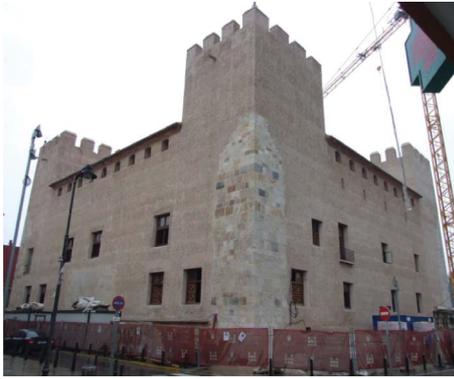
Figure 1. View of the castle in the final processes of the restoration works. In this image we can notice the extension of the of the valencian rammed-earth in the walls.

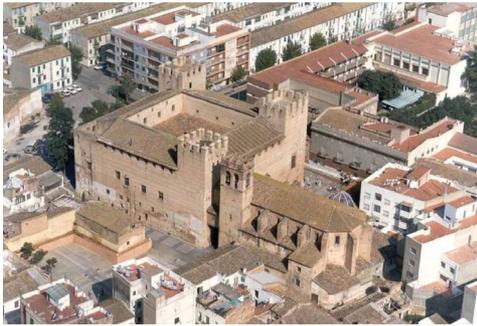
Figure 2. Air view of the castle before starting the restoration works, where can be noticed the northwest tower inexistence.

Even so, in 1928 and in a clandestine way, there took place the partial demolition of the northwest tower, whose reconstruction is described in this article.

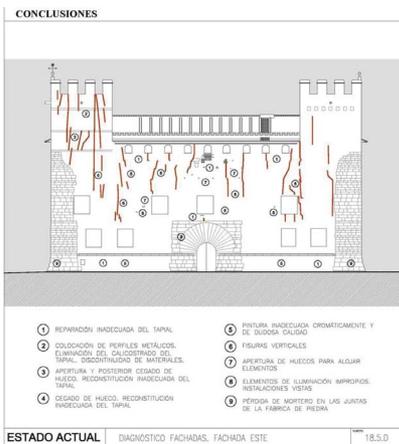
Figure 3. Plan of the previous study included in the Master plan.

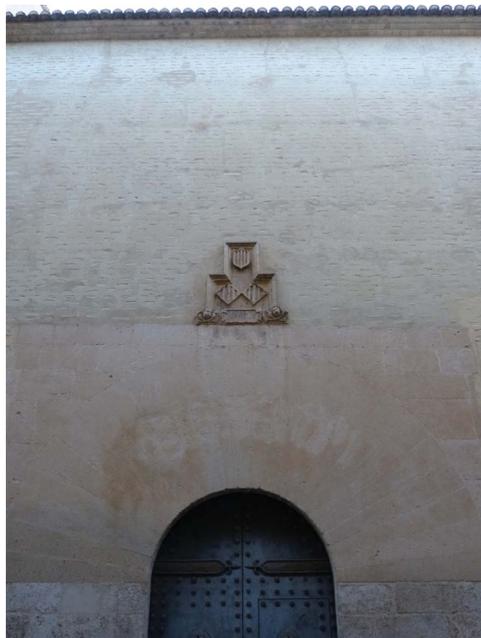
Figure 4. Xàtiva's Almudín façade, in which the valencian rammed-earth wall can be seen, built on the ashlar brickwork.

Property of Local Relevancy, or in the Ribera and the Costera areas in several examples of public or residential buildings such as the Almudín in Xàtiva.

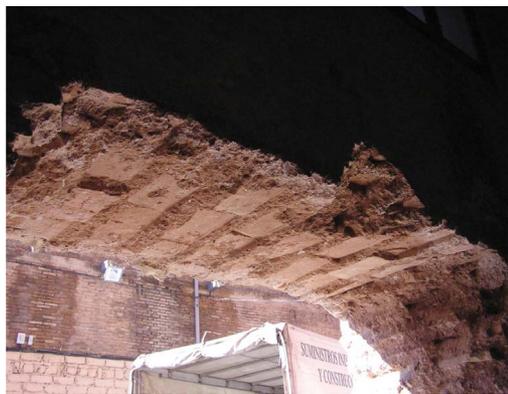
Figure 5. Hollow horizontal section done in the rammed-earth wall of the Alaquàs castle where can be seen the traces of the bricks internal disposition.

This technique, based on archaeological studies carried out in the Alaquàs castle, consist of the construction of brick courses lying on the rammed-earth arranged lightly separated from the façade surface, so that once the different layers of lime and clay are poured, the bricks remain sunk of the superficial crust, giving it such a characteristic image.

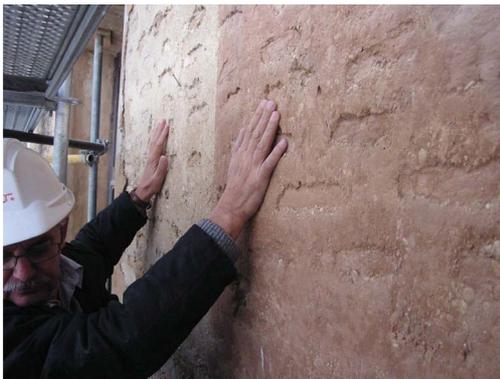
Figure 6. Cleaning tests to remove the existent painting by means of aluminium silicate projection.

The approach when intervening was to correct these faults detected in the preliminary study and some others not previously detected but that followed the same typology. The first task in the intervention was responsible for removing a layer of acrylic painting present in the whole building. The method used for this cleaning up works was aluminium silicate projection at low pressure to remove the painting without damaging the appearance of the rammed-earth wall.

Once this work was done, it was proceeded to consolidate the surface by means of a spraying of potassium silicate so that it achieved a greater superficial resistance in those areas that presented superficial degradation.

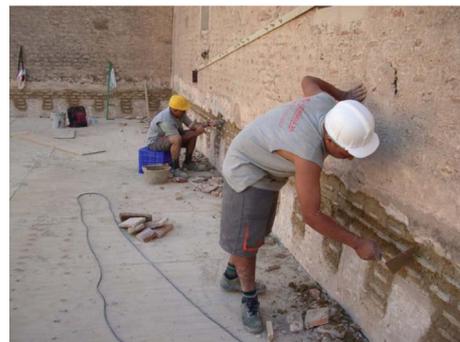
Figure 7. Reintegration of the rammed-earth wall in those areas with hollows of the former supports of the wooden beams.

Independently of the established concept for the volumetric recovery of the fourth tower that will occupy the third area of intervention, we refer to the rammed-earth wall's recovery to complete those hollows that had been open in previous stages, work that impelled an architectural recovery of the original spaces that had been distorted after several refurbishments and adjustments adding brickworks of another nature, that although it was not passing for a mimetic copy of the rammed-earth wall, it was necessary to give a superficial unique aspect to the rest of the rammed-earth wall. It is here where the execution and finishing techniques might be questioned but not the intention of recovering the rammed-earth wall aspect to unify wall faces.

The proposal raised as suitable for this kind of intervention was to build up a brickwork wall with solid brick courses measuring  $28 \times 14 \times 3$  cm and a lime mortar with dosage 1:4, using the arids of the area to get a good integration with the existing brickwork. According to the location of the face to recompose, the different courses followed a cadence alternating 3 or 4 header courses and one stretcher course. The horizontal joints were about 6 to 10 cm thick, being the horizontal joint from 2 to 3 cm thick.

Later, the outer plaster layer was made with lime mortar of dosage 1:3 with the same arids and pigments dosages that integrated with the annex brickwork. In some cases a superficial patina for a suitable chromatic reintegration was used.

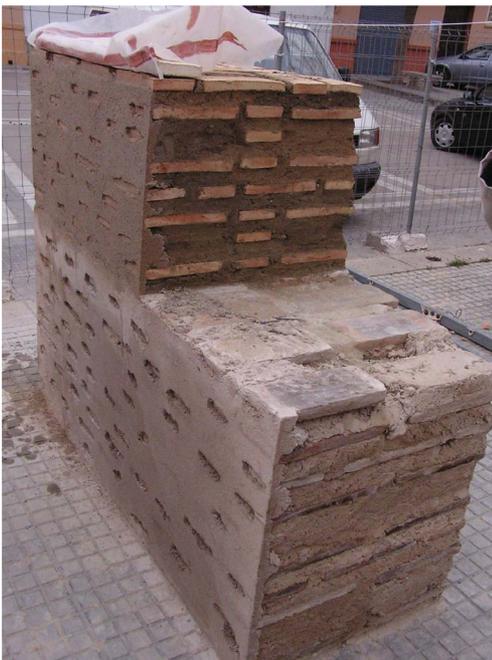
Figure 8. Tests carried out to build the valencian rammed-earth wall.

To do that, an exhaustive study of different faces of the castle walls was carried out, with a particular emphasis in the composition of the bricks' jointing grid where the brick's faces are slightly in the background and in the colour and superficial texture of the rammed-earth wall; this last aspect will be based on the dosage of the lime mortar crust. To do so, different samples of a composition of thin arid and lime grout adding the use of mineral pigments were carried out.

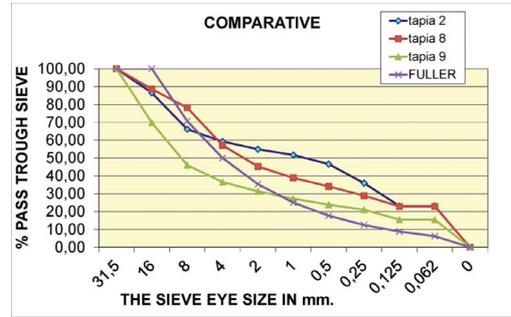
Figure 9. Granulometry of three rammed-earth walls samples compared with Fuller.

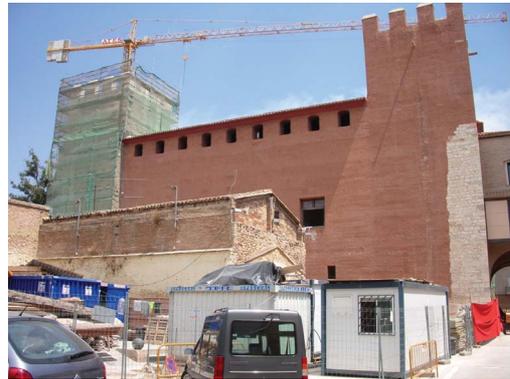
Figure 10. Image of the fourth tower during the reconstruction process.

The reconstruction of the fourth tower was, with no doubt, the work to which more time was devoted to the decision of the carrying out and the selection of the materials. The decision adopted was to use bricks with similar dimensions to the existing ones and rounded arid for the lime mortars. The rhythms of the bricks disposition were studied and a template to be used as a model was prepared. Over the existing rammed-earth wall a brick course was placed marking the difference between the intervention done and the existing wall.

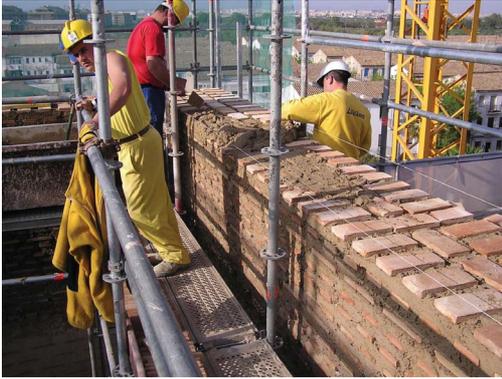
Figure 11. Image of the process of placement of the brick course in the brickwork of the fourth tower during the reconstruction process.

the walls was not followed as we lacked the proper formwork of this technique that formworked the front parts of the wall faces in such a way that when tamping, the mass would flow around the bricks giving them their characteristic aspect. Due to this, the adopted solution in the reconstruction of the fourth tower can be considerate as a brickwork to the image of the valencian rammed-earth wall.

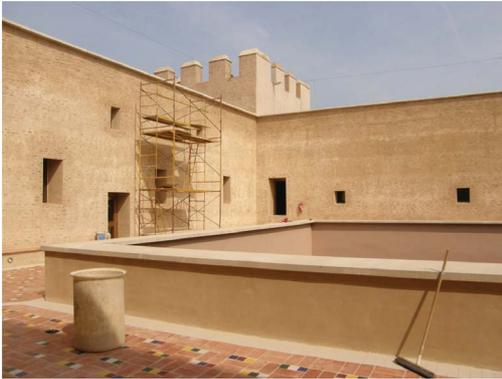
Figure 12. Image from the courtyard during the reintegration and reconstruction works of the fourth tower.
